The drive behind ANSTO CORIS360 technology to
find a lost radioactive capsule

Australia Nuclear Association

October 2023

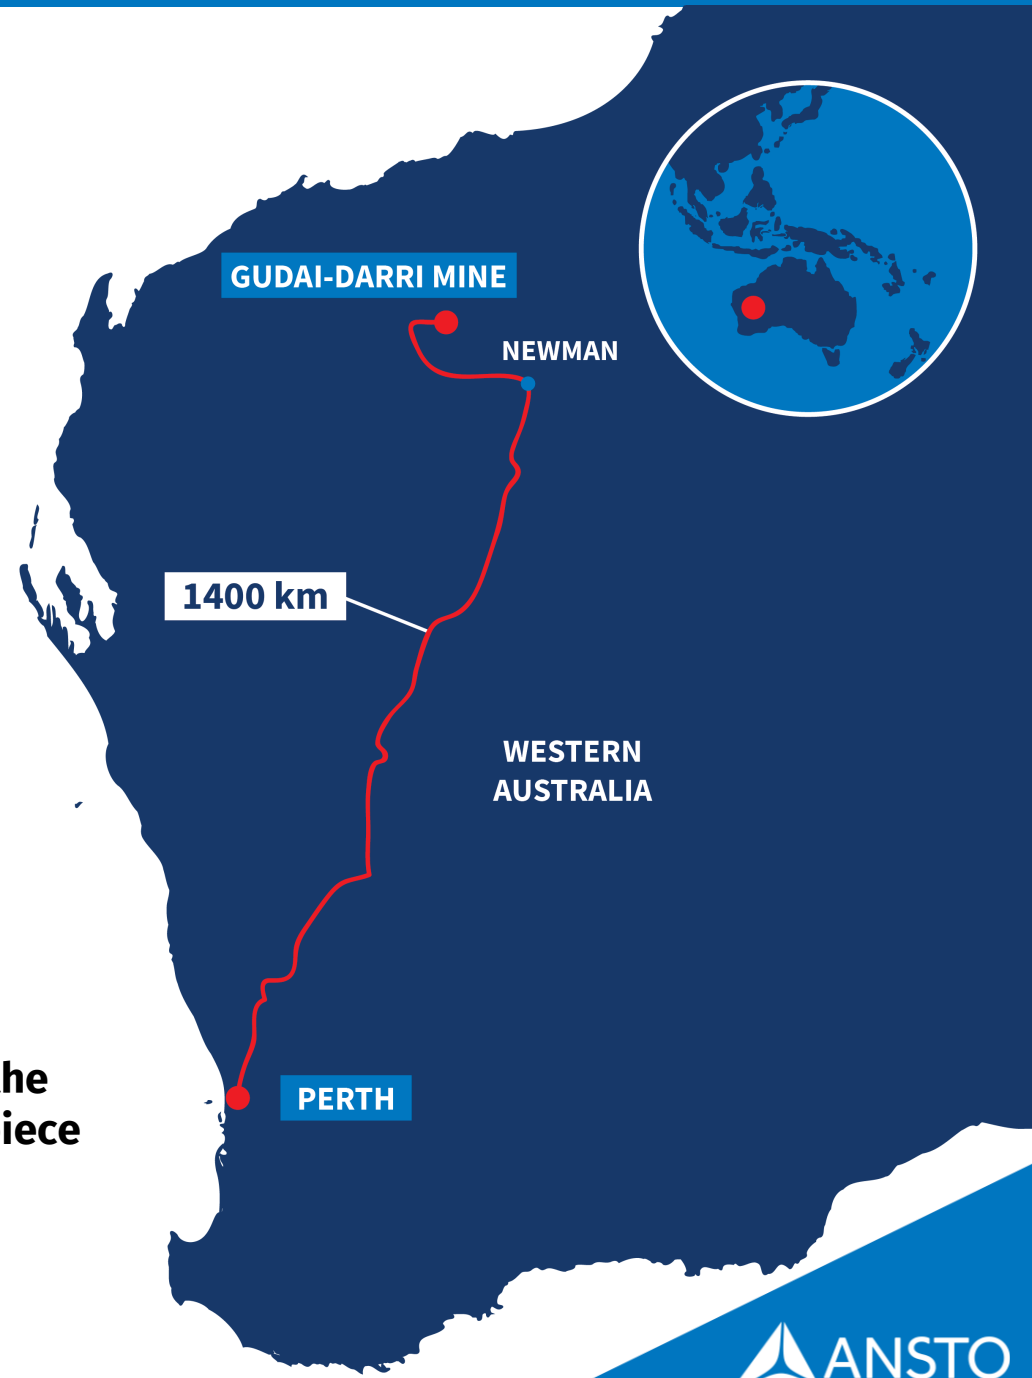
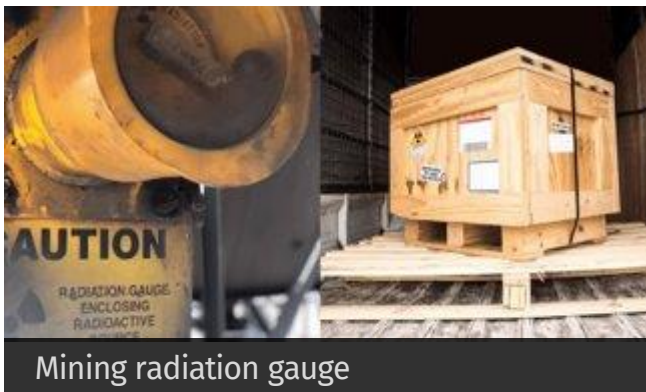
Mining radiation gauge

^{137}Cs Capsule was the size of a ten cent piece

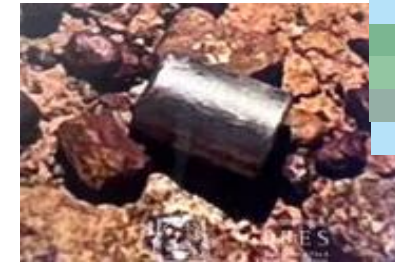
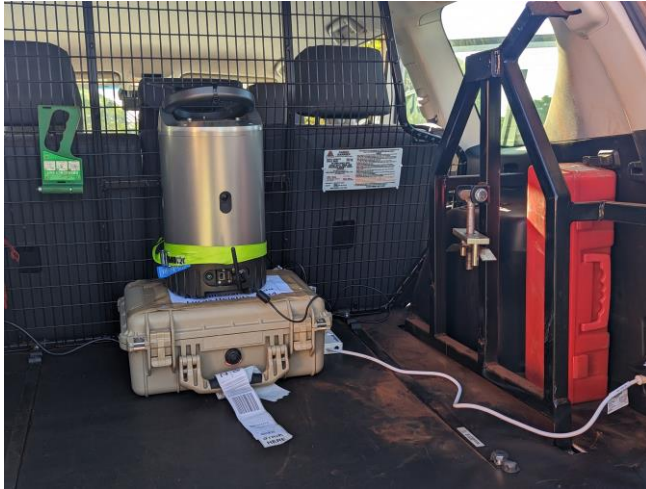
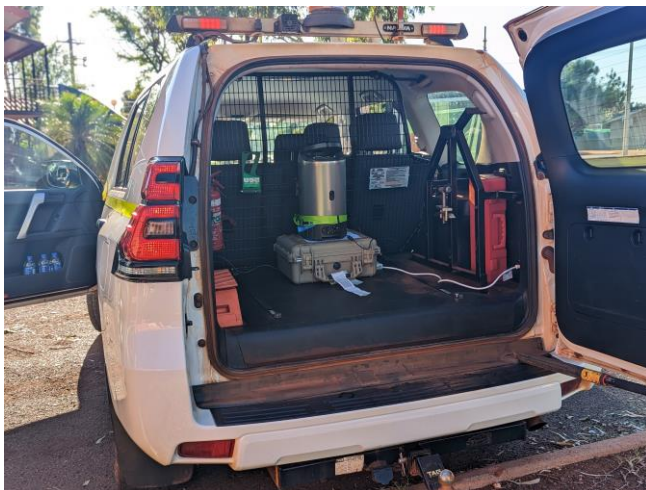
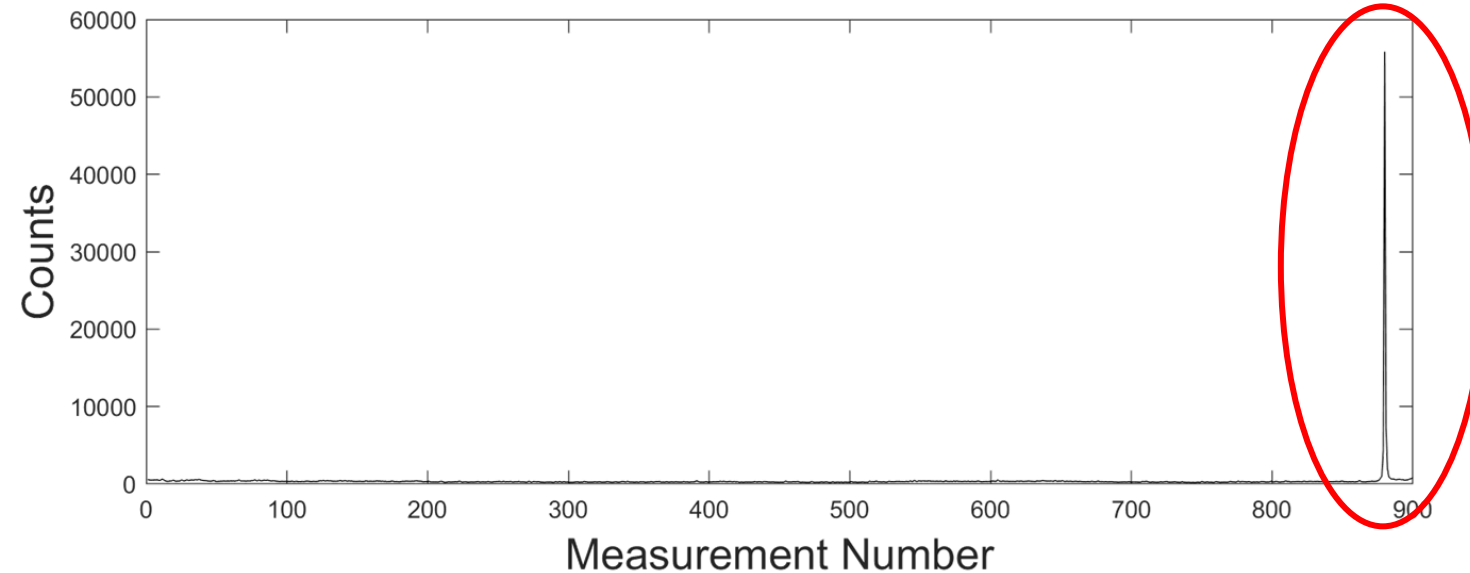
Finding lost WA source

- Modified CORIS360[®] system in “search mode” (pictured) is secured in back of van
- Suite of equipment (such as NaI Detectors) was utilized for holistic identification and redundancy
- Device spikes as van drives past source at 70 km/hour (circled)
- Multiple devices began to alarm indicating significant nearby source

Counts per second

ANSTO's CORIS360® image locating the radioactive capsule

- Site secured and perimeter established → include readings
- Standard CORIS360® device then used to pinpoint exact location of source in ~1 min
- Calculate dose constraints
- Plan recovery methodology
